Allied Home Inspections

Report Identification: Sample Inspection

Address: 1234 Drive San Antonio, TX 78258

PROPERTY INSPECTION REPORT FORM

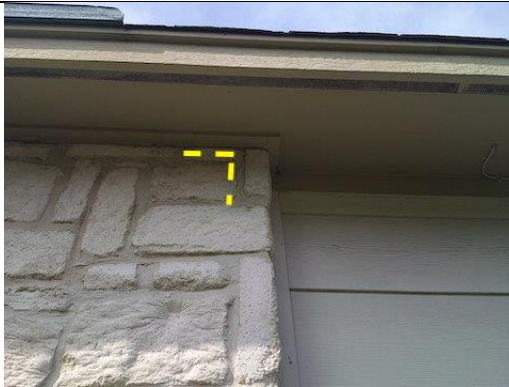
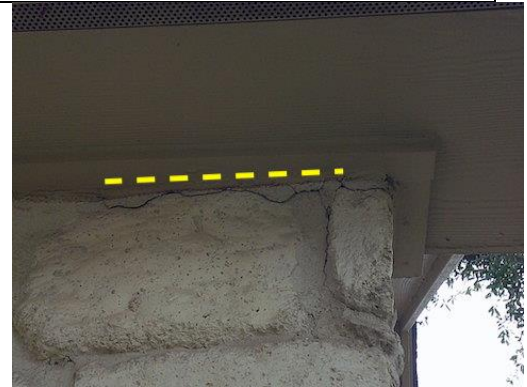
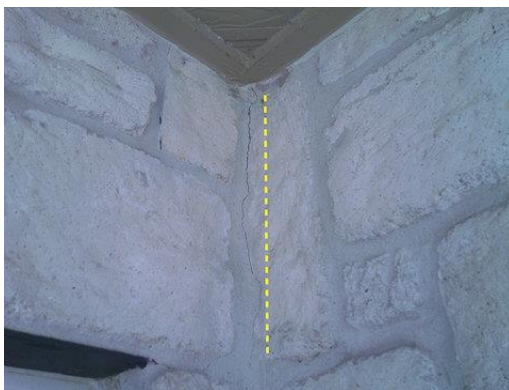
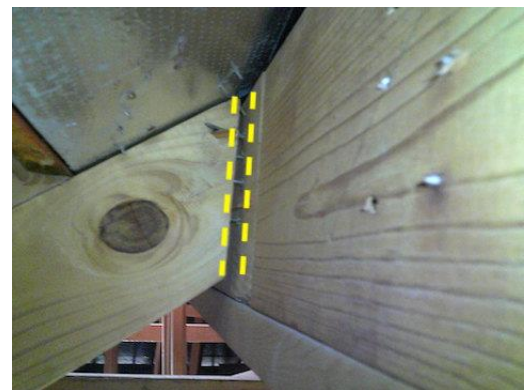
In this inspector's opinion the foundation appeared to support the structure without an immediate need of remediation at the time of this inspection; however, there are indications of some previous and/or ongoing settling/movement listed above. If the settlement/movement is a concern, consider performing a structural investigation to determine if the settling/movement warrants remediation by a structural engineer. In this inspector's opinion, the settlement does not appear to have caused foundation failure or significant structural concerns on the day of the inspection. Continued settling could result in future structural issues, therefore, consider improving all items that contribute to settling (grading, drainage, erosion). Cracks in the drywall, exterior wall cladding, and parging should be monitored for changes.

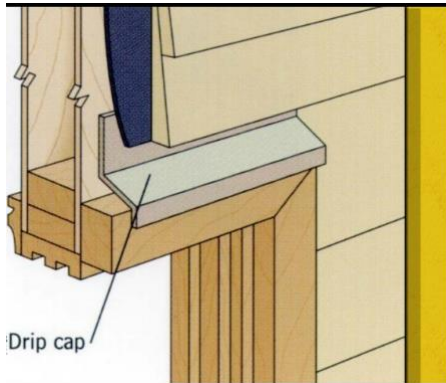
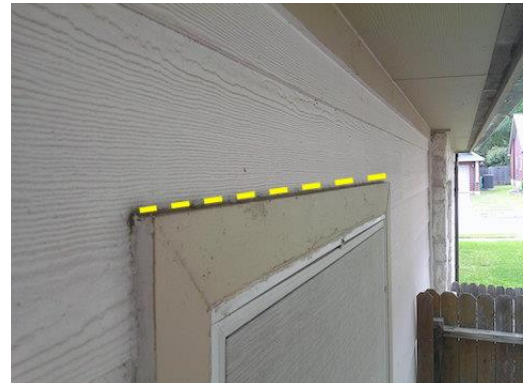
1. Mortar is separated or missing in some areas
2. Caulking / Sealant separated or missing in some areas (Deficient per TREC)
3. Some siding fasteners backed out
4. Lacking flashing and / or incorrectly installed (Deficient per TREC)

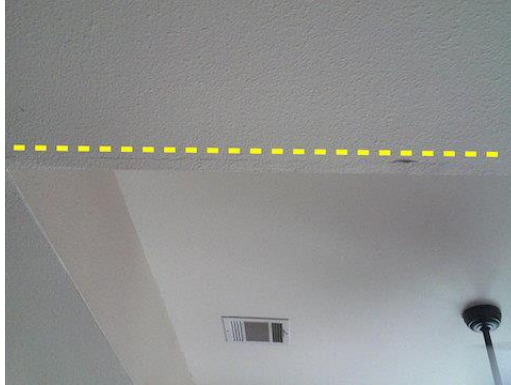
1 Master Bedroom

1. Ceiling cracks in some areas

Written Opinion: **Recommend improvements to the items above by a qualified professional. Ceiling cracks should be monitored for future changes to determine if the settling is ongoing or previous movement. Improvements and repairs should include an investigation for resulting latent damage.**

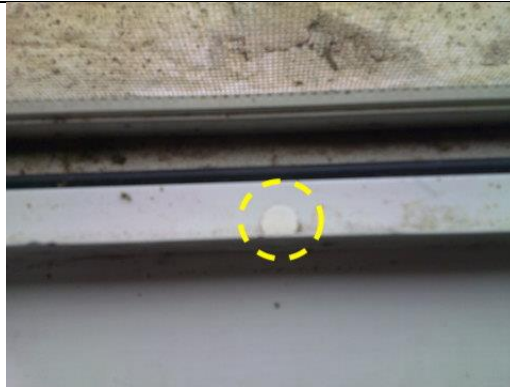
1. Some windows are difficult to open or close

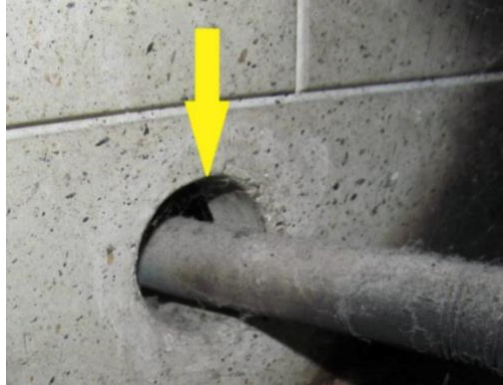
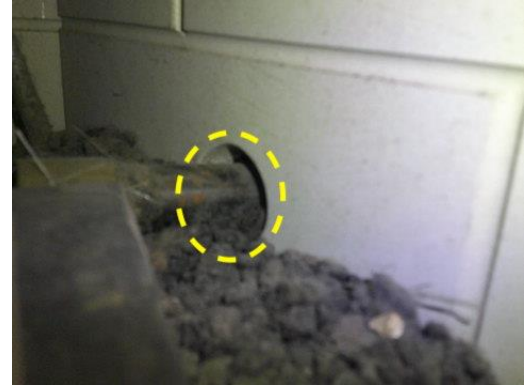
Annular space between the gas line and refractory panel was not sealed. Manufacturer's installation instructions should be followed. Typically, this requires that the annular space be sealed with insulation, high-temp caulk, or medium duty refractory mortar to prevent heated gases from entering the wood framed wall. We recommend sealing this area for fire and personal safety.

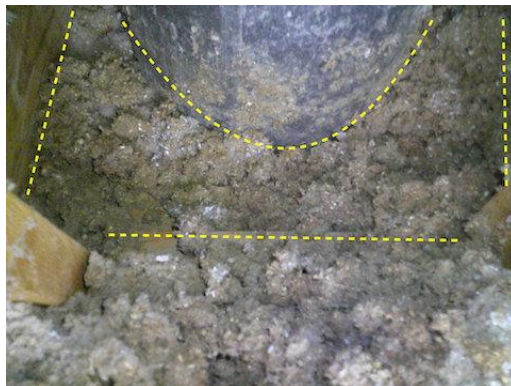
1. Inadequate clearance from combustible materials (Deficient per TREC)

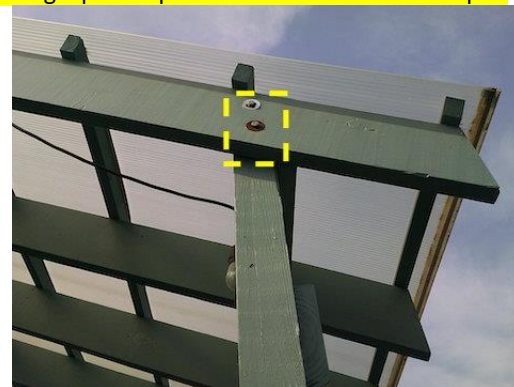
No bearing observed; beams must bear on the post using a post cap bracket or notched technique.

- 1. Structural deficiencies (Deficient per TREC)**

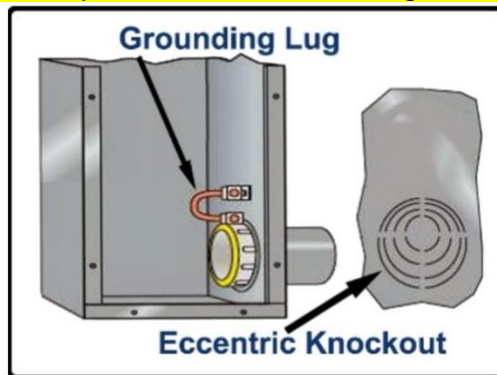
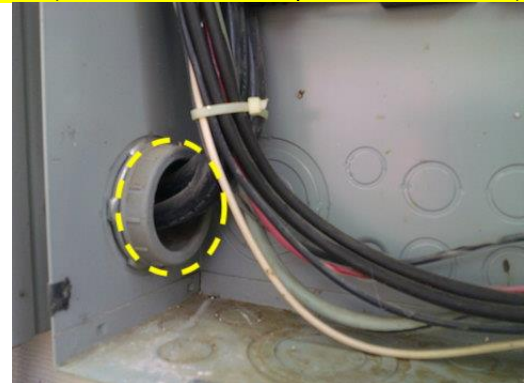
Raceway not bonded to the electrical grounding system. (Human electrocution prevention measure)

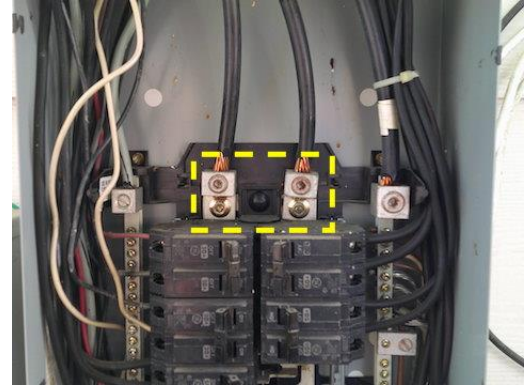
A/C condensing unit specifies maximum 35 Amp Breaker - 50 Amp Breaker in use (Def. per TREC)

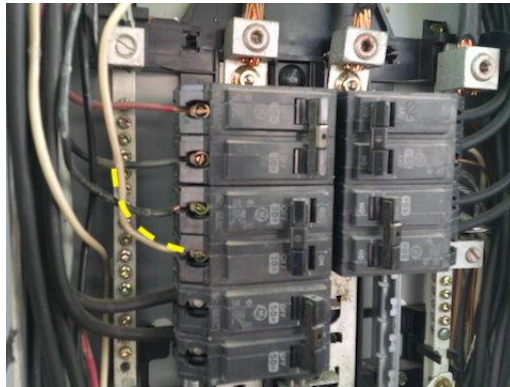
1

1. **Neutral wires serving as conductors; not labeled as required**
2. **Ground wire / rod / CWB could not be verified (Terminated below grade)**

Written Opinion: ***The electrical panels should be evaluated further by a qualified electrician or licensed electrical contractor for but not limited to the items above.***

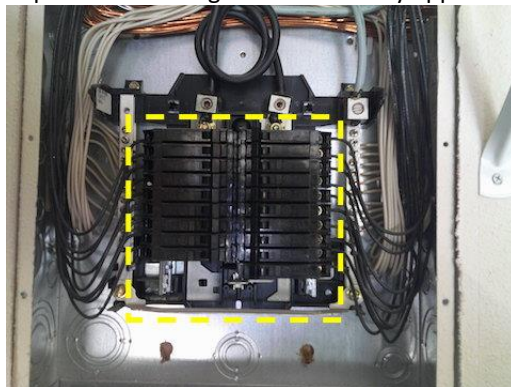
AFCI protection not located at one or more location(s). TREC considers this a recognized safety hazard and deficiency. The Home may have been built before the GFCI or AFCI protection was fully implemented though observationally appears to be functioning as intended on the day of inspection.

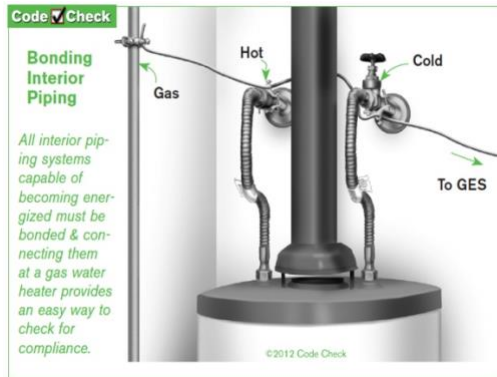
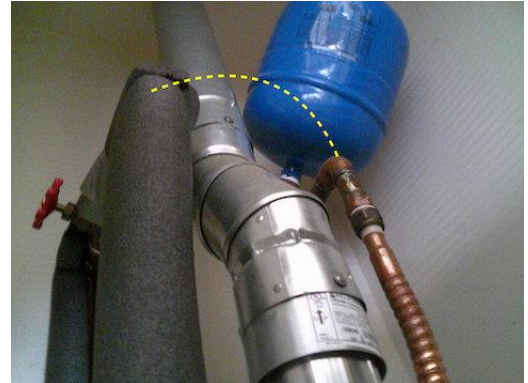
Metallic water pipes were not bonded across the Water Heater per NEC 250.104(B). (Metal systems can become conductors- bonding measures help prevent human electrocution)

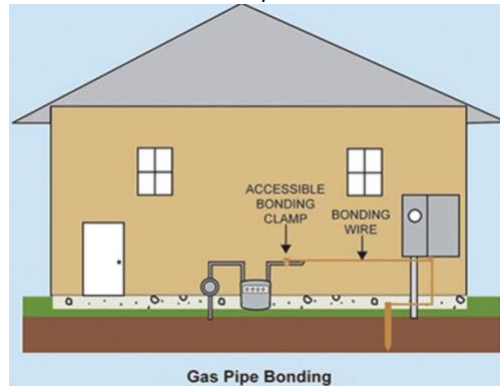
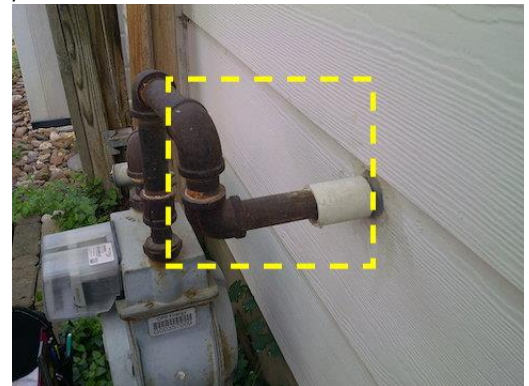
Gas meter piping not visibly bonded as required. (Metal systems can become conductors- bonding measures are meant to prevent human electrocution)

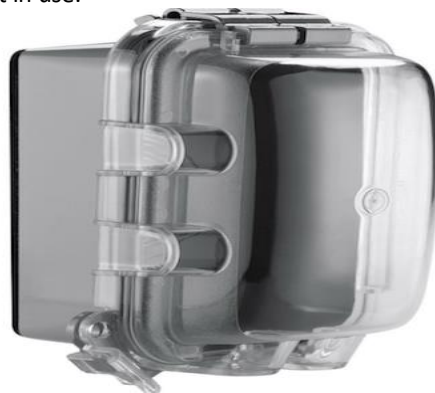
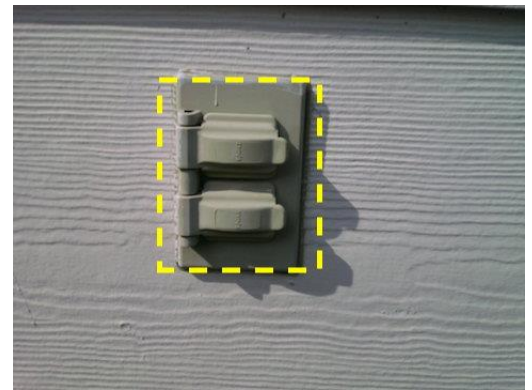
Article 406(8)(A): **Receptacles installed outdoors must have a weatherproof cover** that are acceptable for damp location. These covers are gasketed, sealing the unit from moisture and retarding rain and snow. Article 406(8)(B)(1): Outdoor receptacles located in wet locations that are unprotected from rainfall, must have **a cover that is weatherproof to protect the receptacle when a cord is plugged** into it and when not in use.

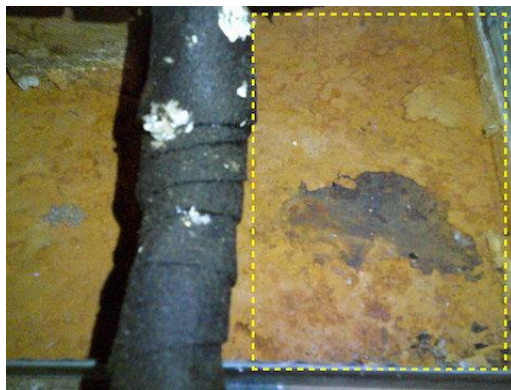
2

1. Water or rust in auxiliary / secondary drain pan
2. Lack of GFCI near unit for technician (No picture)

Written Opinion: ***Air conditioner unit(s) operation presented no significant defects on the day of the inspection; however, noted items above should be improved or repaired and maintenance/cleaning performed twice per year.***

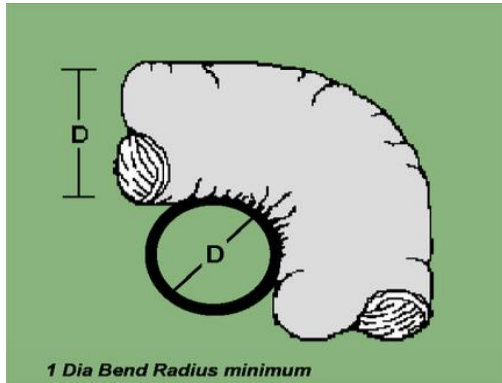
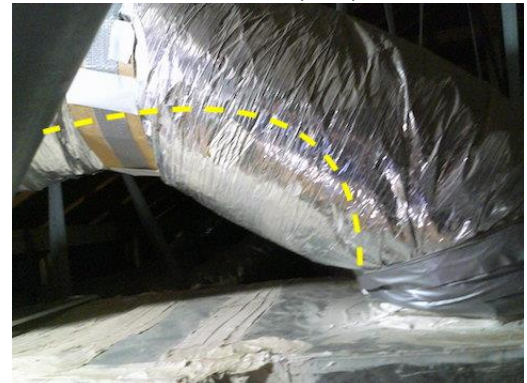
- Inadequate support of ductwork: contacts earth, other ductwork, framing members etc.

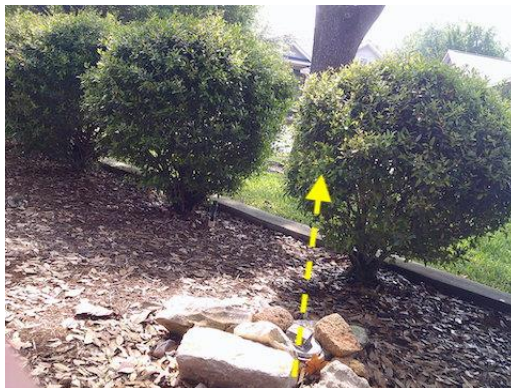
Main waste drain cleanout in-line with large trees; increased likelihood of damage from root System(s). Recommend monitoring the area for changes related to subsurface leaks.

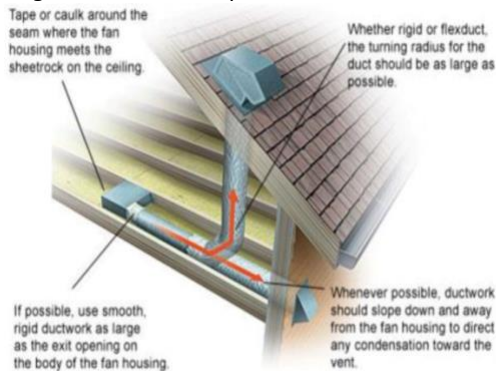
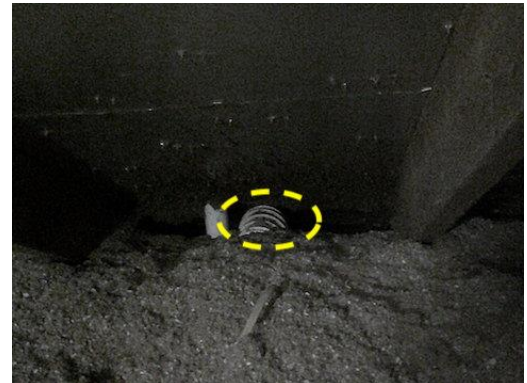
One or more bathroom exhaust fans did not terminate outside the building. We were not able to view the point of termination for *some/all* of the bathrooms' exhaust fans to allow a full inspection and evaluation. No roof or wall jacks were observed which could have served as a point of termination. Vents, therefore, were presumed to terminate within the attic or at the soffit. Air removed by mechanical exhaust systems should be discharged to the outdoors, not exhausted into an *attic, soffit, ridge vent, or crawl space.*
