Allied Home Inspections

Report Identification: Sample Inspection

Address: 1234 Drive San Antonio, TX 78258

PROPERTY INSPECTION REPORT FORM

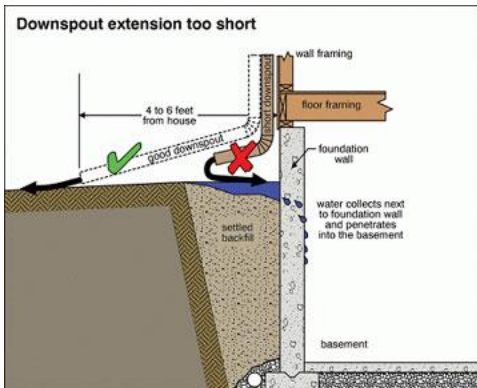
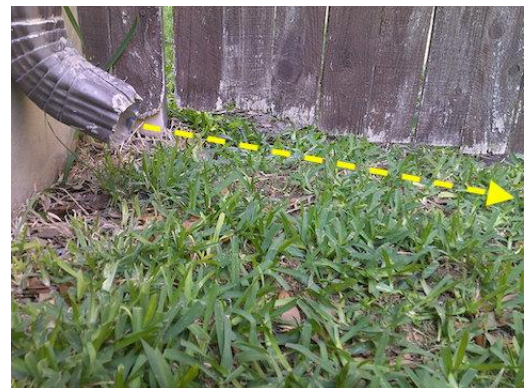
OBSERVATIONS: (photos may be listed above or in Foundation section)

- Erosion or ponding next to foundation**

Gutters and downspouts were installed at some eaves of this structure. As a structural improvement, we recommend that all horizontal fasciae have gutters installed with downspouts directing water at least 5' away from the structure. Water allowed to cascade from 8' to 10' onto grade encourages erosion and ponding. **According to Texas Department of Housing & Community Affairs 2.3**, "Rain gutters shall be installed if none exist. Gutters shall slope 1" for every 20 linear feet with downspouts installed at a minimum every 40'. Downspouts shall discharge water at least 5' from the foundation. Care must be taken to not discharge water onto adjacent properties."

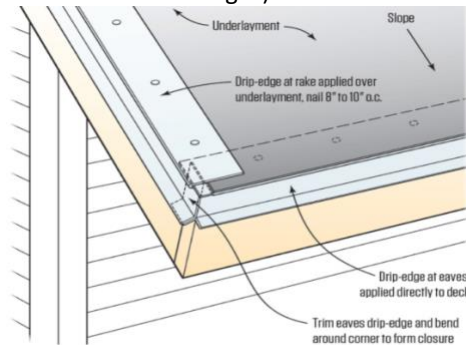
Rain drip edge flashing not located, or installation appeared improper. (Deficient per TREC) (Directs run-off over and off the edges)

R905.2.8.5 Drip edge: A drip edge shall be provided at eaves and gables of shingle roofs. Adjacent pieces of drip edge shall be overlapped a minimum of 2 inches (51 mm). Drip edges shall extend a minimum of 0.25 inch (6.4 mm) below the roof sheathing and extend up the roof deck a minimum of 2 inches (51 mm). Drip edges shall be mechanically fastened to the roof deck at a maximum of 12 inches (305 mm) O.C. with fasteners as specified in Section R905.2.5. Underlayment shall be installed over drip edges along eaves and under rake edges on gables. Unless specified otherwise by the shingle manufacturer, shingles are permitted to be flush with the drip edge.

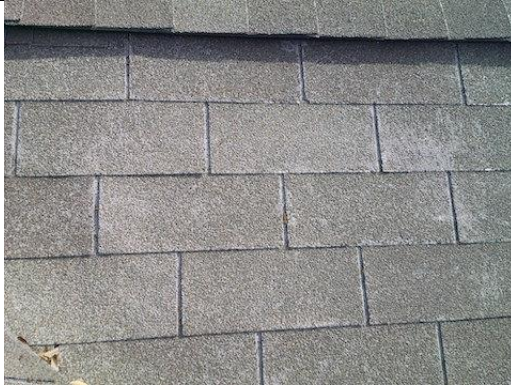
1&2

Written Opinion: ***On the day of inspection, the shingles shown no significant defects apart from the items noted above. This inspector did not examine every inch of the covering. Recommend further evaluation of but not limited to listed items. Repairs and improvements should include an investigation for resulting latent damage.***

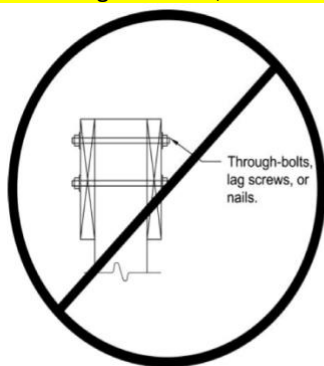
No bearing observed; beams must bear on the post using a post cap bracket or notched technique.

Through-bolts, lag screws, or nails.

Note: Support of beams w/ fasteners only is prohibited. Bearing is required. See Figure 8A.

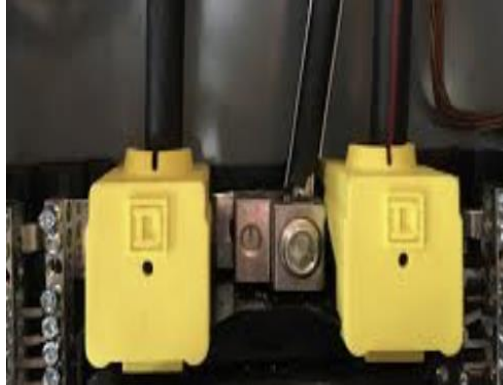
Example Photo

lacking service entrance barriers (UL 67) on service lugs/terminals per 2017 NEC: 408.3(A)(2) Service Panelboards, Switchboards, and Switchgear. Barriers shall be placed in all service panelboards, switchboards, and switchgear such that no uninsulated, ungrounded service busbar or service terminal is exposed to inadvertent contact by persons or maintenance equipment while servicing load terminations.

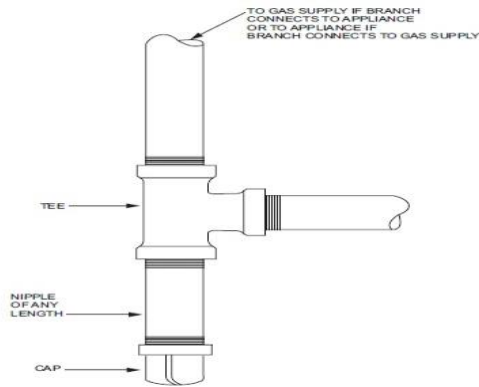
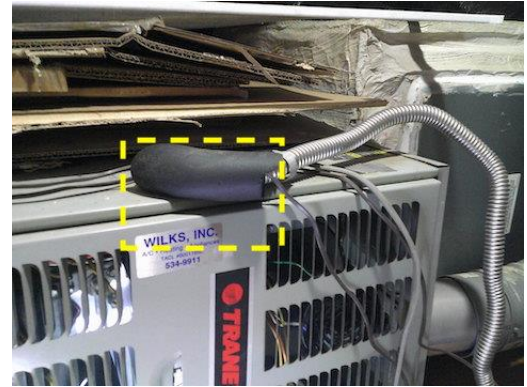
Written Opinion: ***Gas heating cycle operation presented no significant defects on the day of the inspection; however, the items above should be improved to prevent future issues. Thermostats operated in manual mode only. The gas heating cycle was checked by placing the system into the heating mode, adjusting the thermostat to demand heat, and observing a) flame ignition b) fan operation c) heat generation and d) cessation of fan operation when the demand was withdrawn. Flame impingement, uplifting flame, improper flame color, or excessive scale buildup may reflect damage to the heat exchanger and the general condition of the unit(s) and will be reported if observed. A full and complete evaluation of a heat exchanger requires that the furnace unit be dismantled and is, therefore, beyond the scope of this inspection. Note that without regard to performance at the time of this inspection, the age of the unit(s) must be considered regarding remaining life.***

Reference for Best Practice-408.4 Sediment Trap: Where a sediment trap is not incorporated as part of the appliance, a sediment trap shall be installed downstream of the appliance shutoff valve as close to the inlet of the appliance as practical. The sediment trap shall be either a tee fitting having a capped nipple of any length installed vertically in the bottommost opening of the tee as illustrated in [Figure 408.4](#) or other device approved as an effective sediment trap. Illuminating appliances, ranges, clothes dryers, decorative vented appliances for installation in vented fireplaces, gas fireplaces and outdoor grills need not be so equipped.

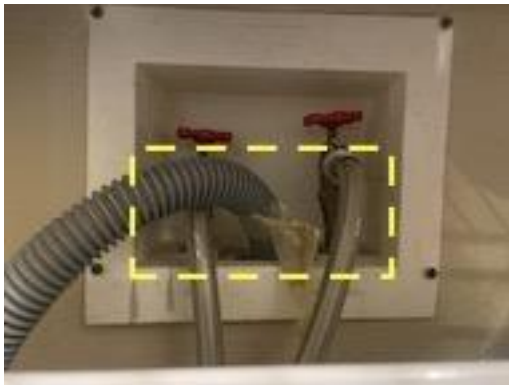
OBSERVATIONS: Washing Machine Connections

1. Washer drains and valves not tested; it is not possible to recreate a washer machine output
2. Washing machine connected at this time - faucets, drains not tested for proper operation
